REPAIR AND REPLACEMENT OF ARCHITECTURAL METALS

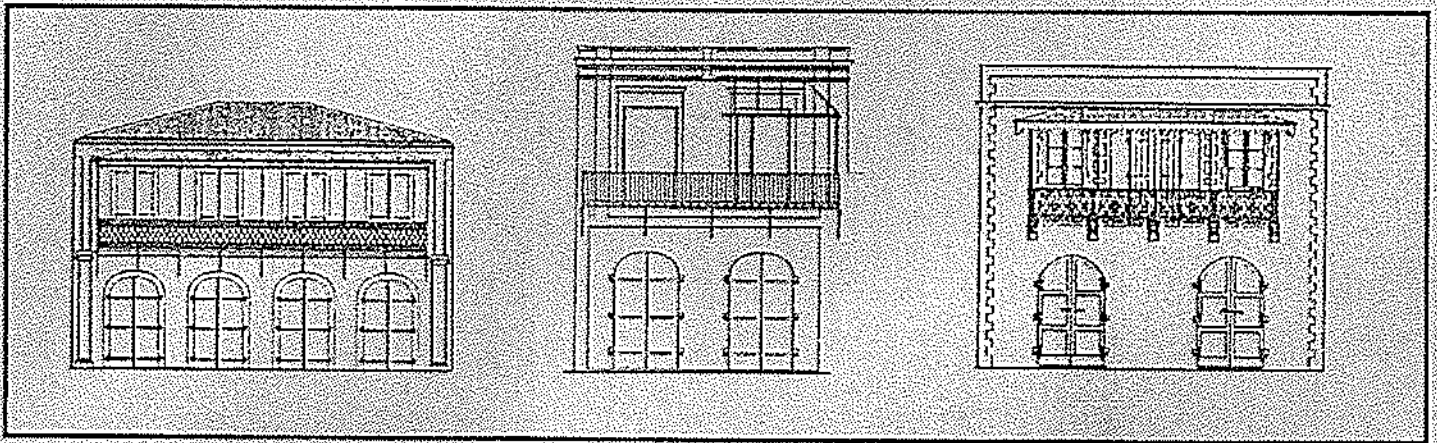
While relatively rare, there are a number of exceptionally high quality cast and wrought iron balconies in the Virgin Islands.

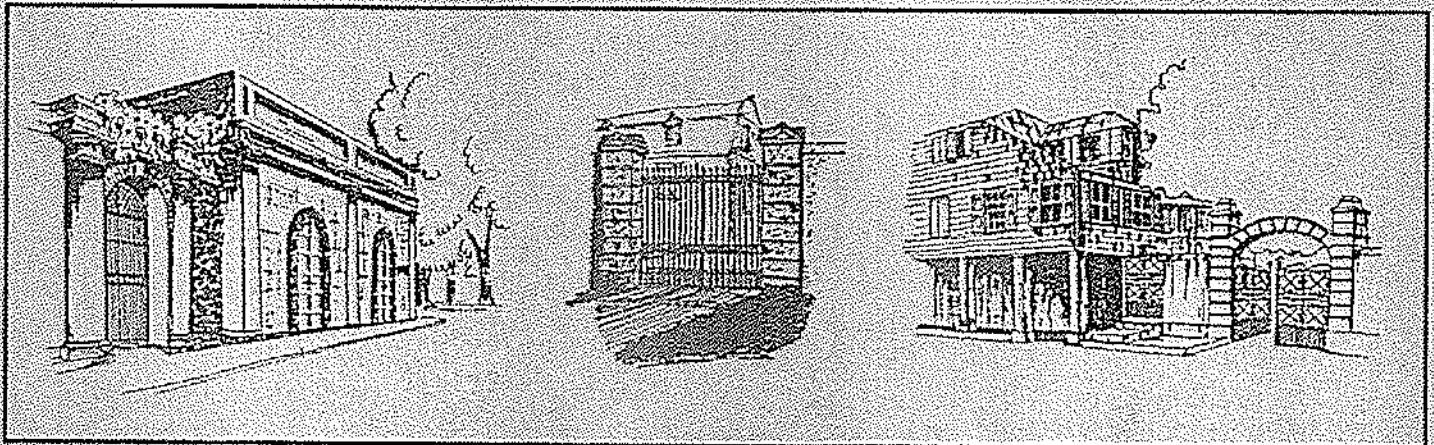
Gateways are another common place where historic metal work is found. Efforts should be made to preserve original or otherwise historic examples.

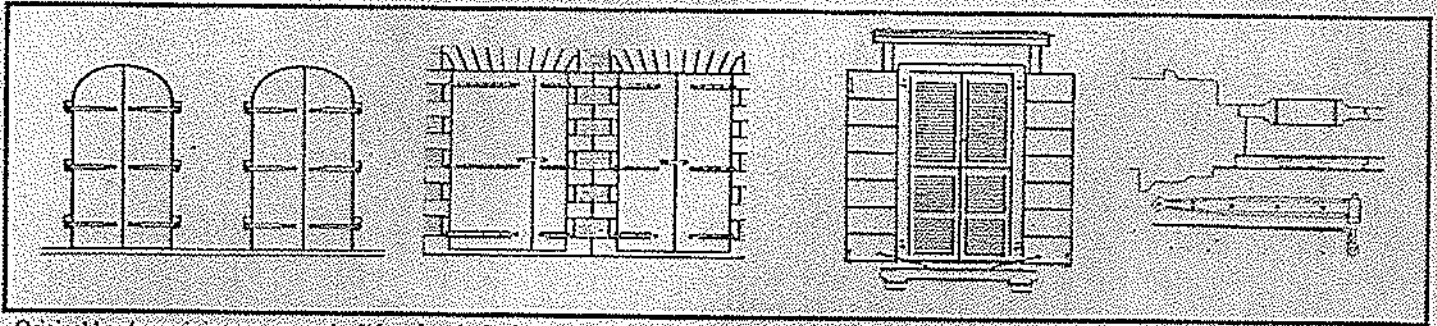
Original hardware is important to the "historic value" of older buildings. Always, existing hinges, hooks and other hardware should be reused or, where pieces are missing, duplicated during repair or rehabilitation work.

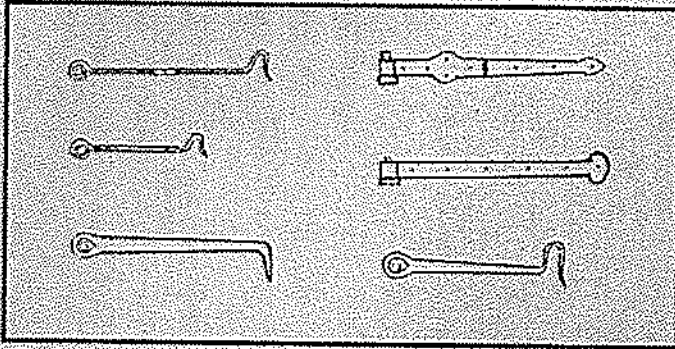
Examples of historic hinge and hook types.

Replacement hinges, pintles, and hooks and eyes for shutters and doors should be duplicated accurately whenever possible. If the cost is too high, simple wrought iron strap hinges may be substituted. These should be painted to blend in with the

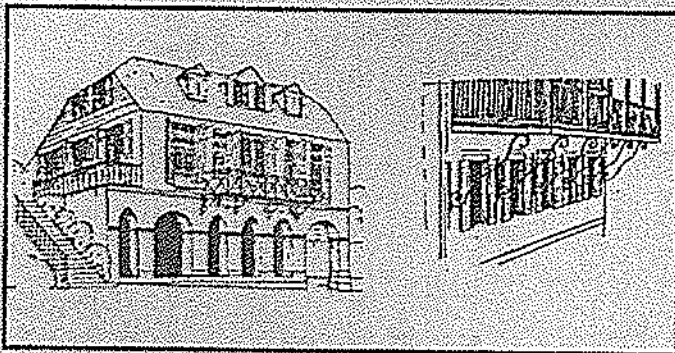
There are numerous examples of wrought iron brackets throughout the Virgin Islands. Existing examples should be retained. Replacement pieces should match originals.

Metal brackets for balconies or signs, following traditional shapes, can be easily obtained or made-up by local metal workers. Care should be taken to duplicate other old examples in the islands, if none can be found on the building.

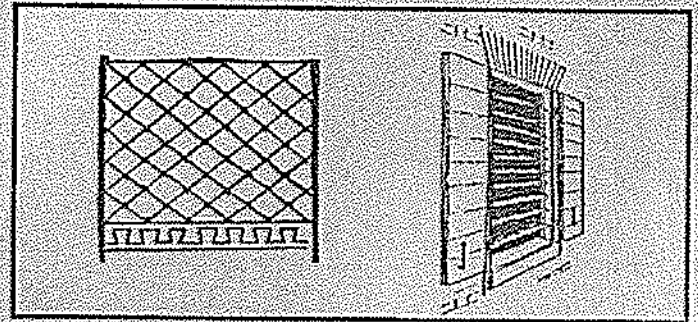
Security grills should be kept as simple as possible. The use of historic metal grill - such as that shown on the left - is one possible solution. Horizontal metal - or even wood - bars, shown on the right, is another.

When a window opening needs to be protected, the simplest solution is usually the best one. Wrought iron bars, ideally square in section and set into the frames horizontally, are a good

traditional solution to security needs. For maximum protection, the bars should be set directly into the masonry.

Ornate, decorative grillwork is completely out of character with traditional buildings in the Virgin Islands and should be avoided. Most of this iron-work is not particularly strong and is less effective than simple iron bars. Another solution, however, if a more decorative treatment is sought, is simple, plain-designed grillwork of a generally contemporary character. There are several contractors and craftspeople capable of this kind of work, and their design can often add greatly to the quality of a rehabilitation job.
