PRESERVATION GUIDELINE 5

Division for Archaeology and Historic Preservation

Virgin Islands Department of Planning and Natural Resources

THE REPAIR OF STONE WALLS

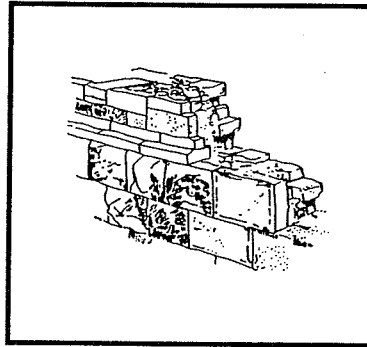
Typical masonry work. Note, even when outer layers are evenly coursed cut stone, much of the interior of the wall is still rubble. Water penetration remains the main problem for preserving such walls.

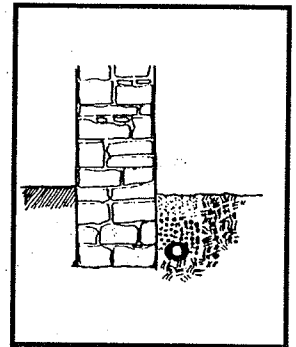
Installation of a perimeter drain can help cut down on moisture problems. Set perforated drain in a bed of gravel and be certain that the ground slopes away from building and that the pipe also drains.

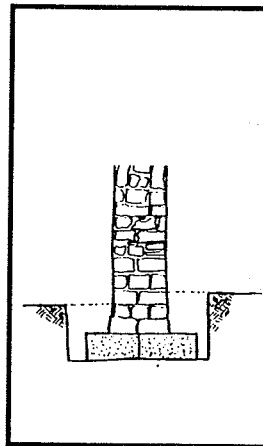
Excavating and providing a proper concrete footing can help correct a failing masonry wall.

If a wall is leaning outward or shows other signs of falling, the wall may be tied using stainless steel ties and anchors. Otherwise, the foundation should be reinforced, often to the point of providing a new concrete footing. In some cases the wall may have to be rebuilt. If this is done, care must be taken to duplicate the original appearance of the wall.

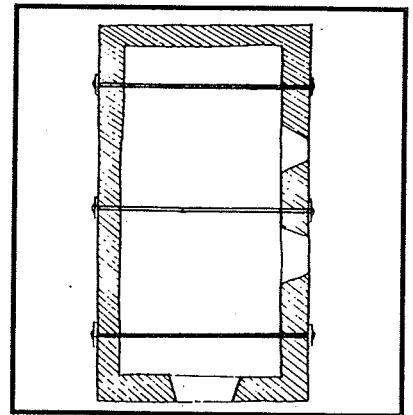
Stainless steel tie rods and anchors can help to stabilize outward-leaning rubble walls. Combined with a concrete footing and, in some cases, a concrete rim ring bond band, ties can help reinforce existing walls. Generally do not attempt to straighten leaning walls!

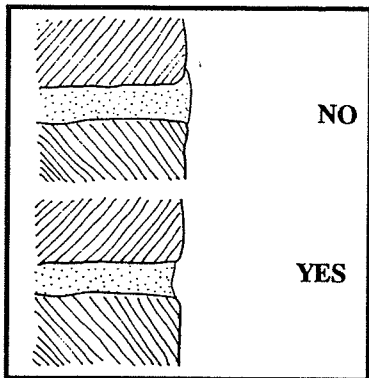
If the mortar between the stones is loose, this should be removed with a chisel and fresh mortar put in its place. Modern Portland cement should not be used for this purpose, as it is too hard for the soft limestone around it.

Efforts should be made to duplicate the finish of existing stone walls. As with brick repointing, joints should be raked out to 2-1/2 times their width and packed with an appropriate mortar. Concave joints are usually preferable. Do Not feather edge as in the top example.

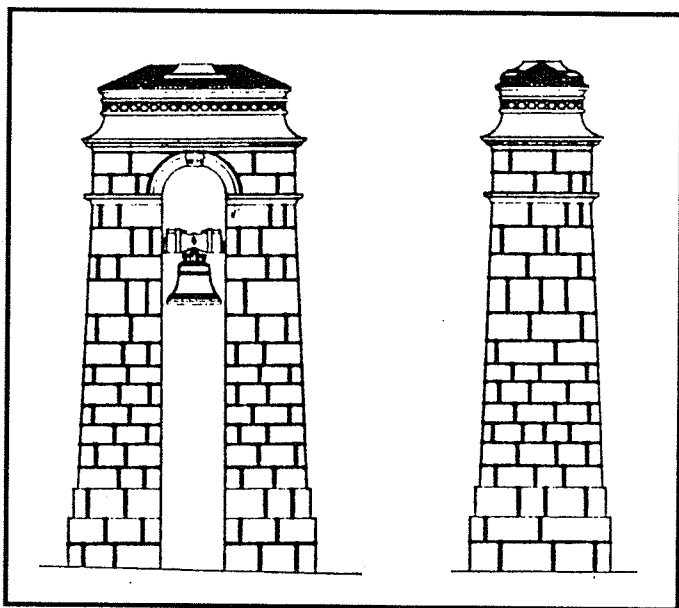
Retain the character and details of original stonework.

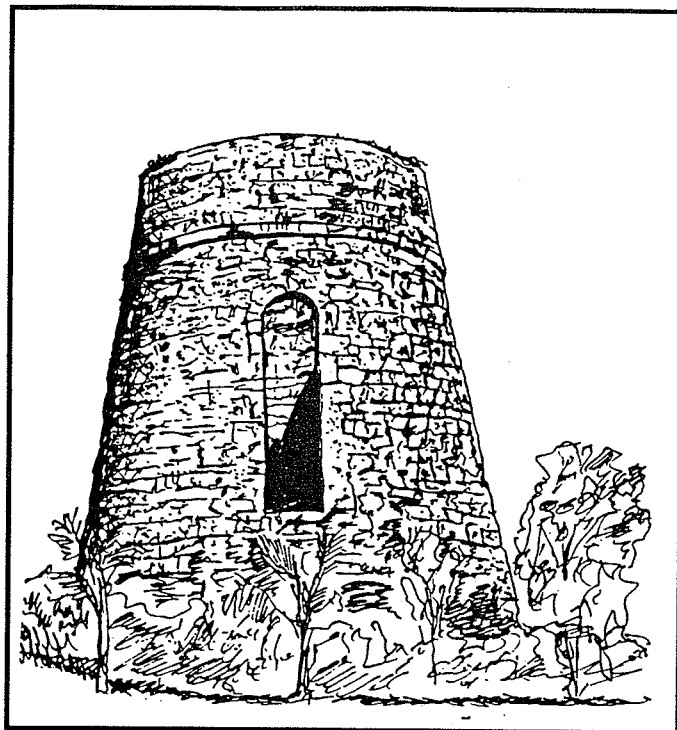
A coat of lime wash can help to protect the surface of stone structures such as these.

Following repointing, a thin coat of lime wash is highly recommended. This coat, being composed of the same material as the wall, will not affect its appearance, but will help to protect from rain and pollution.
