PORCHES, BALCONIES, AND ARCADES

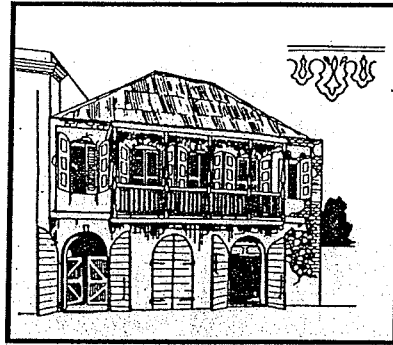
A wood balcony on metal brackets. Kronprindsensgade 68, drawing Pamela Gosner, *Historic Architecture of the Virgin Islands*. Note bargeboard (valence) detail. While a distinctive feature of Virgin Islands buildings, balconies should rarely be added to existing historic buildings unless their prior presence can be documented.

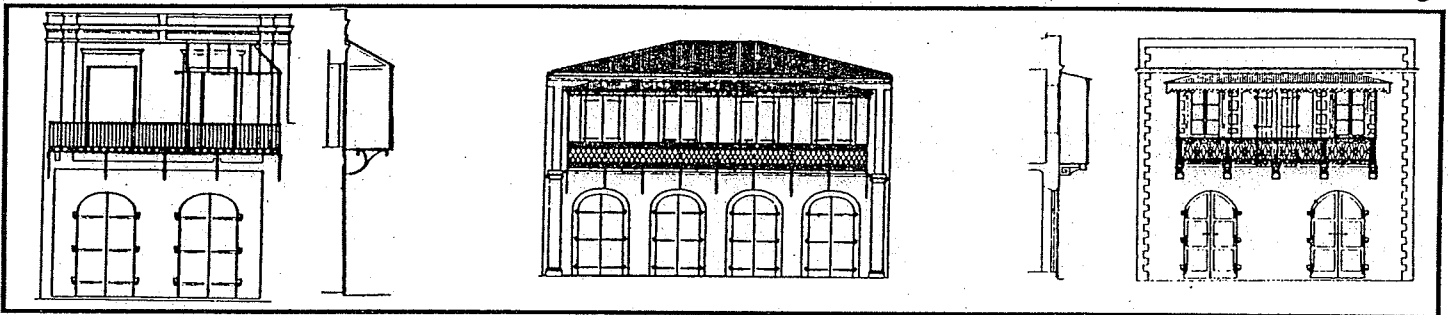
Some outstanding wrought and cast iron balconies.

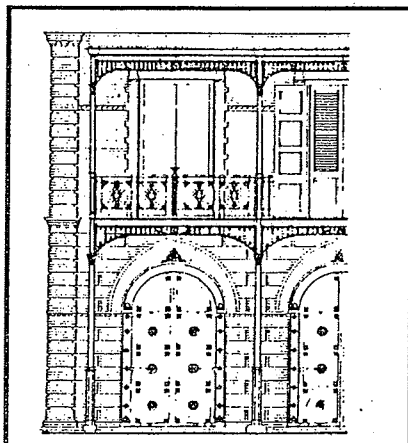
A metal double arcade (two-story), on the former St. Thomas Bank, Charlotte Amalie.

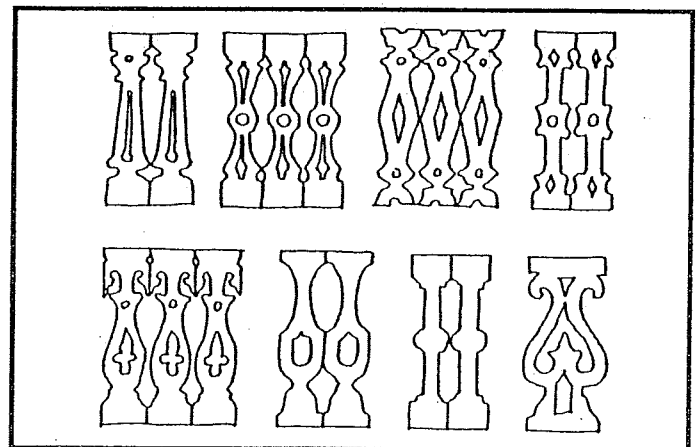
Some common sawn-work balusters. Care should carefully duplicate original patterns when repairing or replacing wood balconies.

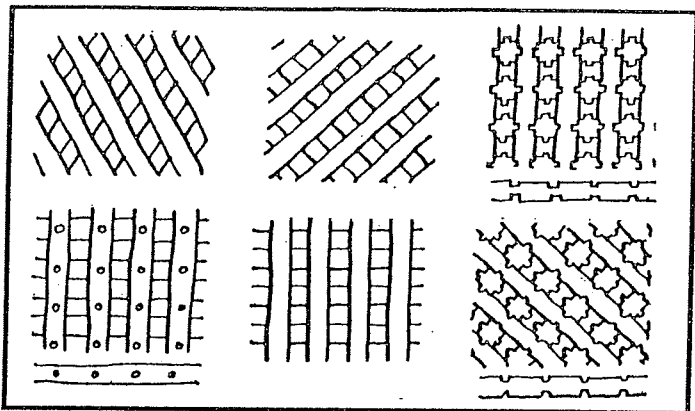
Some common lattice patterns. Lattice was often used instead of balusters for both balconies and verandas.

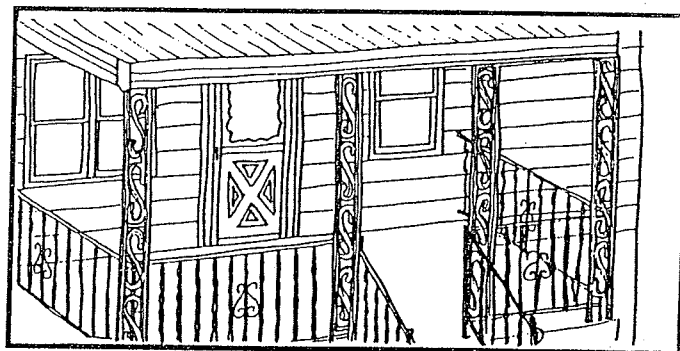
Do not use modern metal posts, rails, or balusters. These detract from a building's historic character.

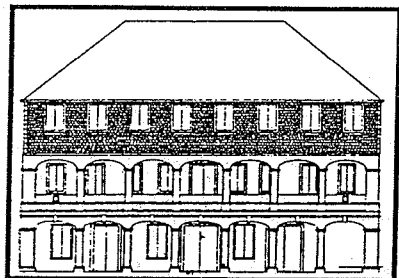
Arcades are important to the historic character of Christiansted and Frederiksted. Every effort should be made to retain existing examples, and replace damaged arcades with new arcades to match.

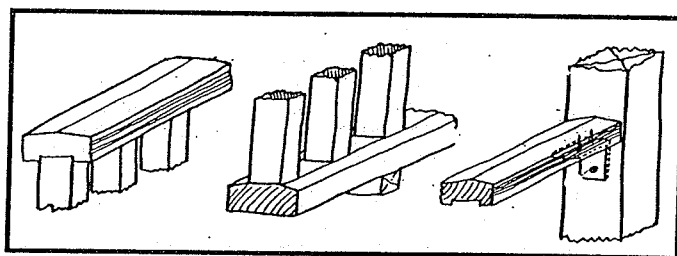
Typical detailing for a simple rail and baluster.

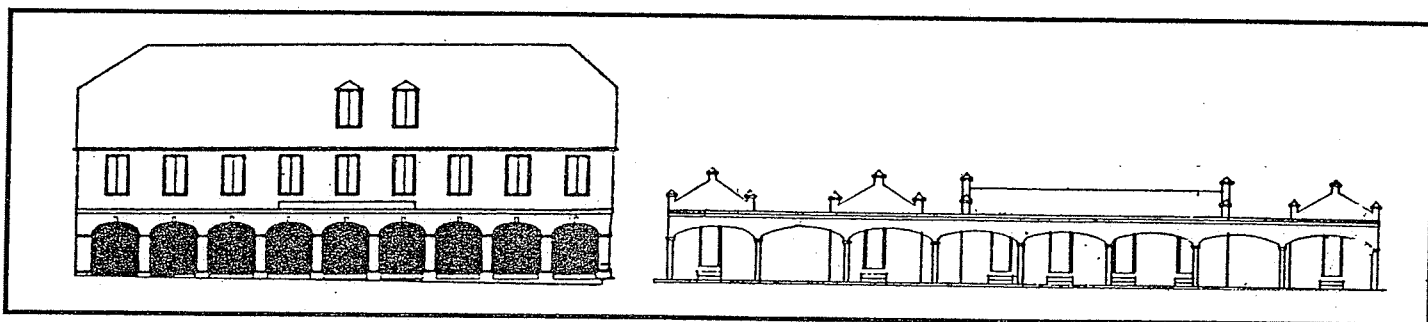
More recent arcades often fail to duplicate essential features of historic examples. The modern arcade in the right hand picture -- built of reinforced concrete -- allows too great a span for arches, which in turn rest on columns too small (visually) to support them.

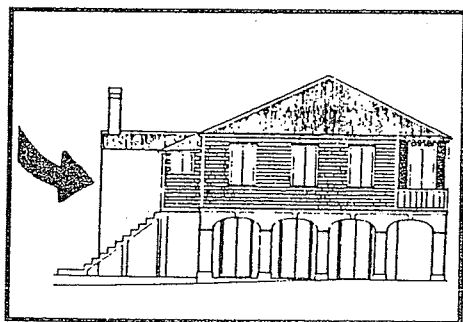
New porches or balconies should be added to rear elevations only -- unless there is historic precedent that can be documented.

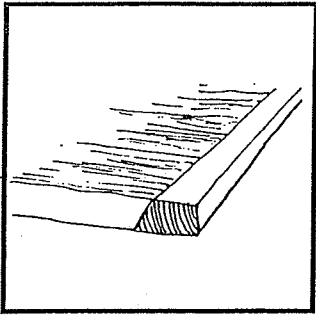
Nosing at the edge of floor decking can help cut down on water penetration.

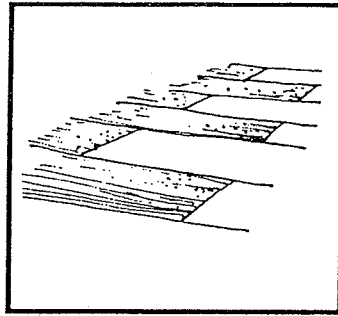
If repairing rotted decking, attempt to splice in replacement boards.

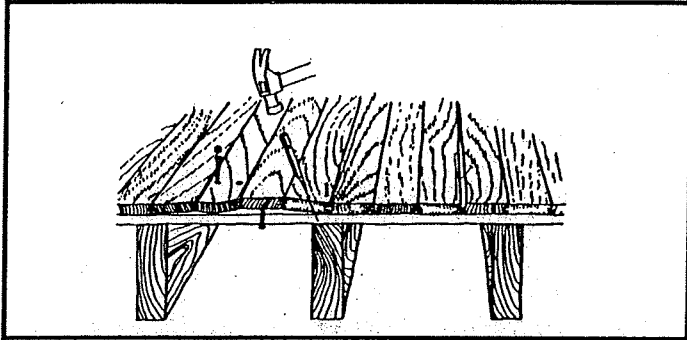
Warped or lifting decking can often be repaired. Always try to repair existing materials rather than replacing wholesale.
